Montgomery County Fire and Rescue Service

POST INCIDENT ANALYSIS

**2nd Alarm Apartment Fire
8708 Barron Street
Takoma Park, MD**

Incident Date: February 16, 2012

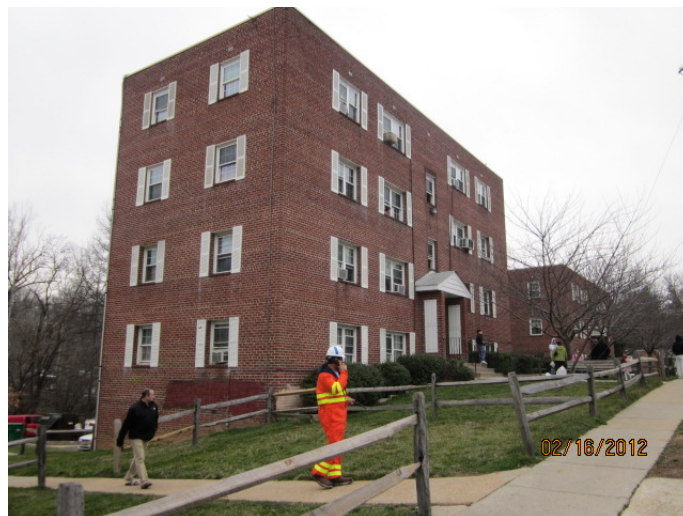
Side B (Exposure B – 8710)

- The fire building “touched” similar buildings at 8706 and 8710 Barron Street – however, there was no interconnection and no fire spread to either adjacent apartment building.

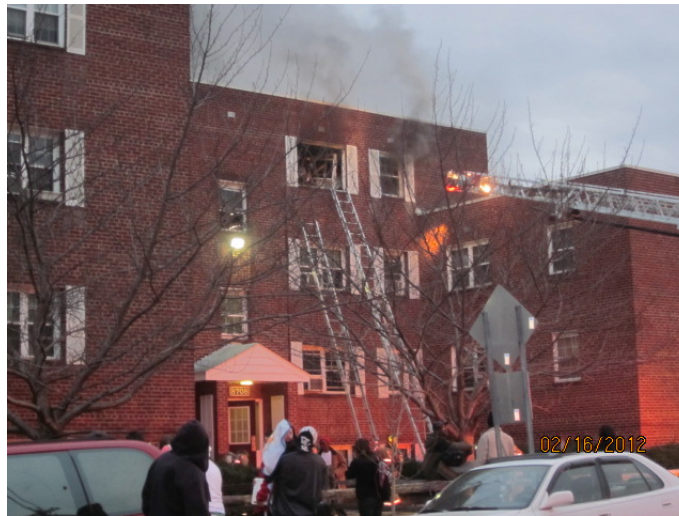
Shortly after the arrival of BC702.

- Upon the arrival of BC701, companies were still stretching attack lines and heavy fire and smoke was evident over the roofline from the Side A vantage point. BC701 also saw numerous occupants at windows on Side A of the structure and assumed that rescues would be needed.
